Strain Monitoring in Water Pipelines

PICA- PIPELINE INSPECTION & CONDITION ANALYSIS CORPORATION

RTS 125+ Distributed Strain Measurement

Inspection Date: January 19 to 22, 2021

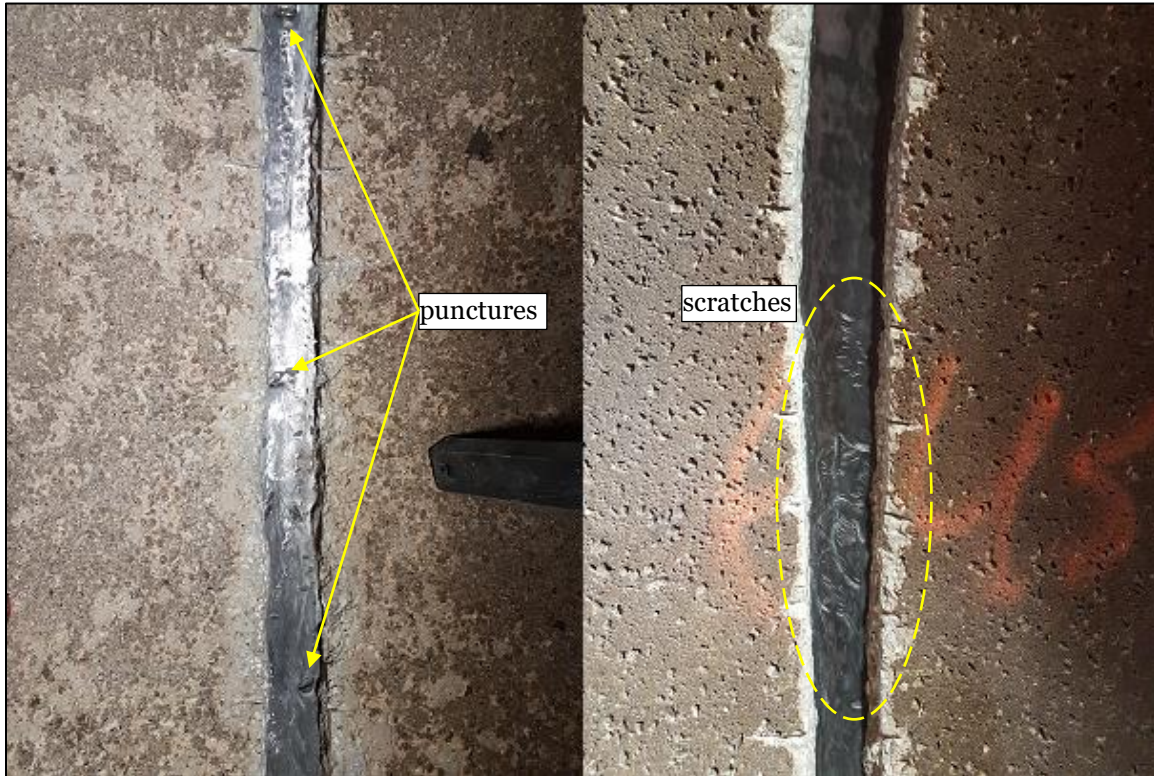
Significant physical exertion was required to remove the 2-inch-thick ring of concrete, and despite best efforts to leave the steel surface unharmed, several marks and punctures were incurred. This is because the amount of force required to chip away the concrete liner differed around the circumference. In some spots the concrete was well adhered to the steel and a technician was obliged to remove concrete with more vigour, while in other spots the concrete spalled off quite easily. The accidental damage never spanned the length of the exposed gap; thus, a strain gauge fiber could still be snaked around the circumference.

Figure 4. Sample of damage incurred during concrete removal: punctures (left) and scratches (right).

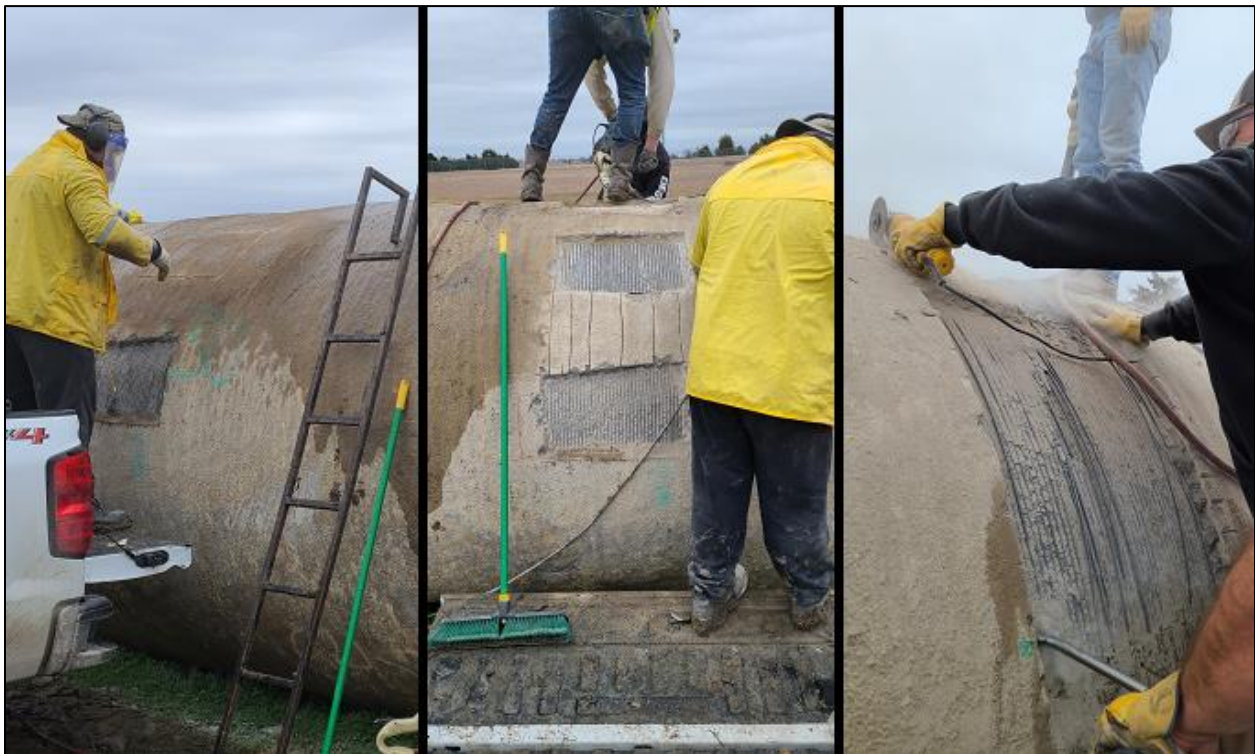
Figure 7. PICA technicians removing an outer concrete window in Segment A at 3:00 (left), at 12:00 and 1:30 (center), and from 3:00 to 9:00 (right)

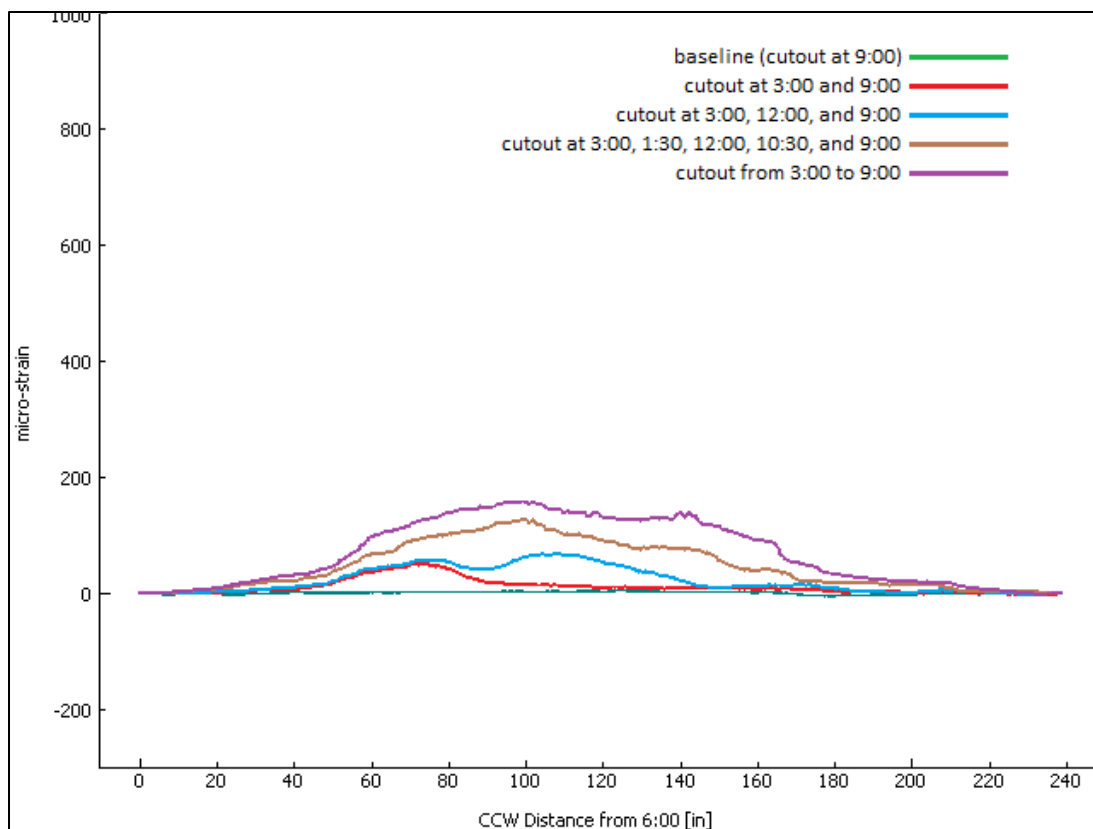
Figure 8 depicts changes to the preload on the embedded steel cylinder resulting from the increased concrete removal.

The green trace represents the baseline scan prior to any new modifications and is depicted as a flat line.

The red trace represents the removal of concrete at 3:00 which is depicted by a perturbation at around 70-inches measured counter clockwise from the invert.

The blue trace represents missing outer concrete at 12:00 and 3:00, depicted as two perturbations centered around 70-inches and 110-inches.

The brown trace represents missing outer concrete at 10:30, 12:00, 1:30, and 3:00 and is depicted as a wide-spread perturbation between 40-inches and 170-inches.

Finally, the purple trace represents the complete removal of outer concrete between 9:00 and 3:00. The strain perturbation grew in amplitude but was still confined to between 40-inches and 170-inches around the circumference.

A surprising outcome of these experiments is that the strain data did not perturb in the vicinity of cut wires as concrete coating was removed around the circumference. If indeed it was the strong bond between wire and concrete which helped retain preload on the embedded steel cylinder, then as concrete was removed the wire should release tension. This release in tension would then lessen the amount of force exerted on the steel cylinder. One interpretation of these observations is that the wire had lost all pretension prior to PICA's pipe modifications – the pipe had been already compromised in this region when it was excavated. Any additional modifications would thus not induce strain changes. The small perturbations observed in the regions where concrete was removed may indicate that the outer concrete also induces some amount of preload, but not as much as the pretensioning wires.

Figure 8. Strain data for outer concrete removal in Segment A. Different colors represent different stages of concrete removal.

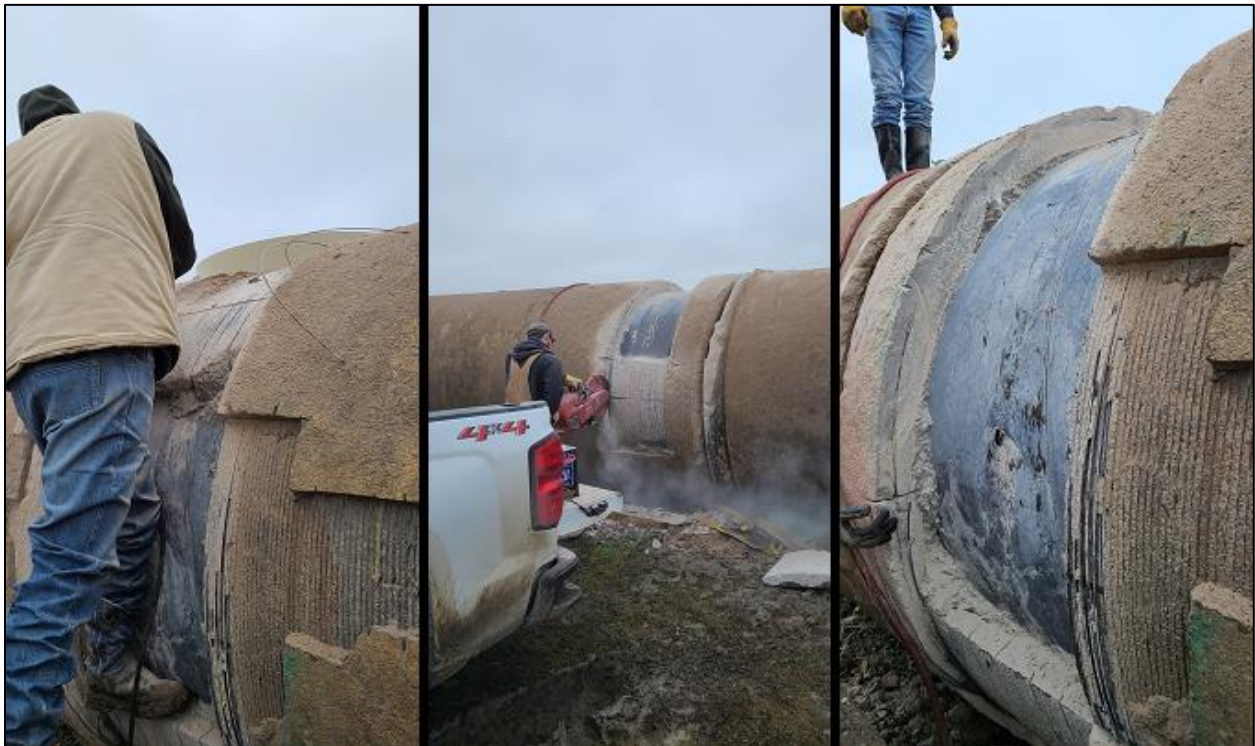
Figure 9. PICA technicians removing concrete and wires in Segment B at 9:00 (left), at 3:00 (center). Bare steel pipe between 7:00 and 5:00 (right).

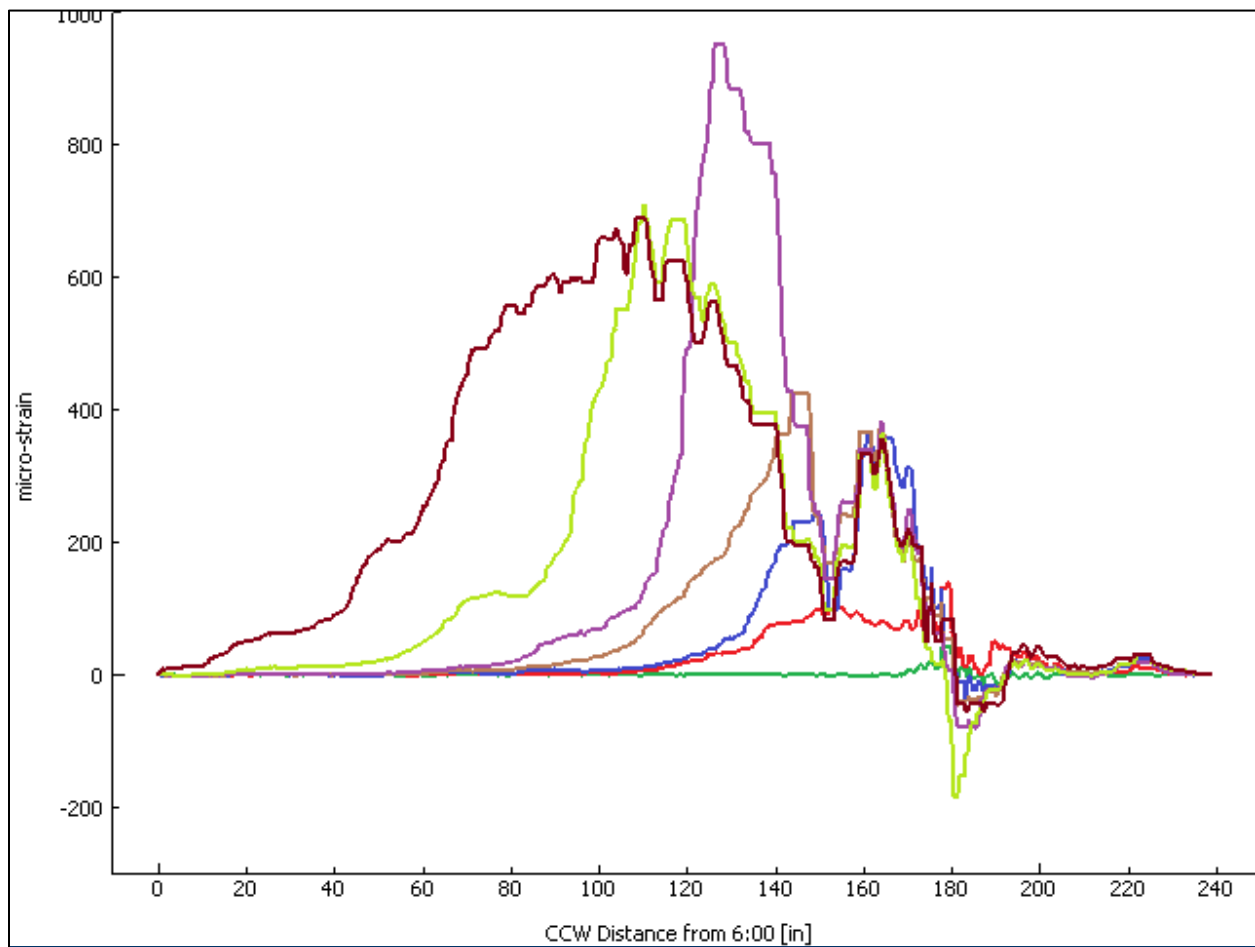
As technicians worked to modify the pipe, the strain gauge continuously recorded changes in pipe characteristics. Figure 10 depicts changes to the preload on the embedded steel cylinder resulting from pipe modifications in Segment B.

The dark green trace represents the baseline scan prior to any new modifications and is depicted as a flat line.

The red trace represents the removal of top layer of concrete, down to the pretensioning wires, between 7:00 and 12:00 circumferential positions.

All remaining traces represent a strain reading recorded every 30 minutes as technicians used the concrete cutting saw to remove concrete.

Interestingly, the red trace representing the removal of just the top layer of concrete and wires closely resembles results from the same action performed in Segment A. All other traces predictably grow in amplitude and circumferential extent representing a larger loss of preload. The downward perturbation at 180-inches from the invert represents the location of a thru-hole that was fabricated in the steel cylinder during PICA's first study. The strain sensing fiber was not adhered to the pipe at this location and simply draped over the hole. The large purple excursion presents a mystery but may be the result of technicians standing on the pipe to make modifications at the crown. This action may have initiated localized strain changes.

Figure 10. Strain data for concrete and wire removal in Segment B. Different colors represent different stages of material removal beginning at 7:00 (220-inches) and continuing in a clockwise fashion to 5:00 (20-inches).

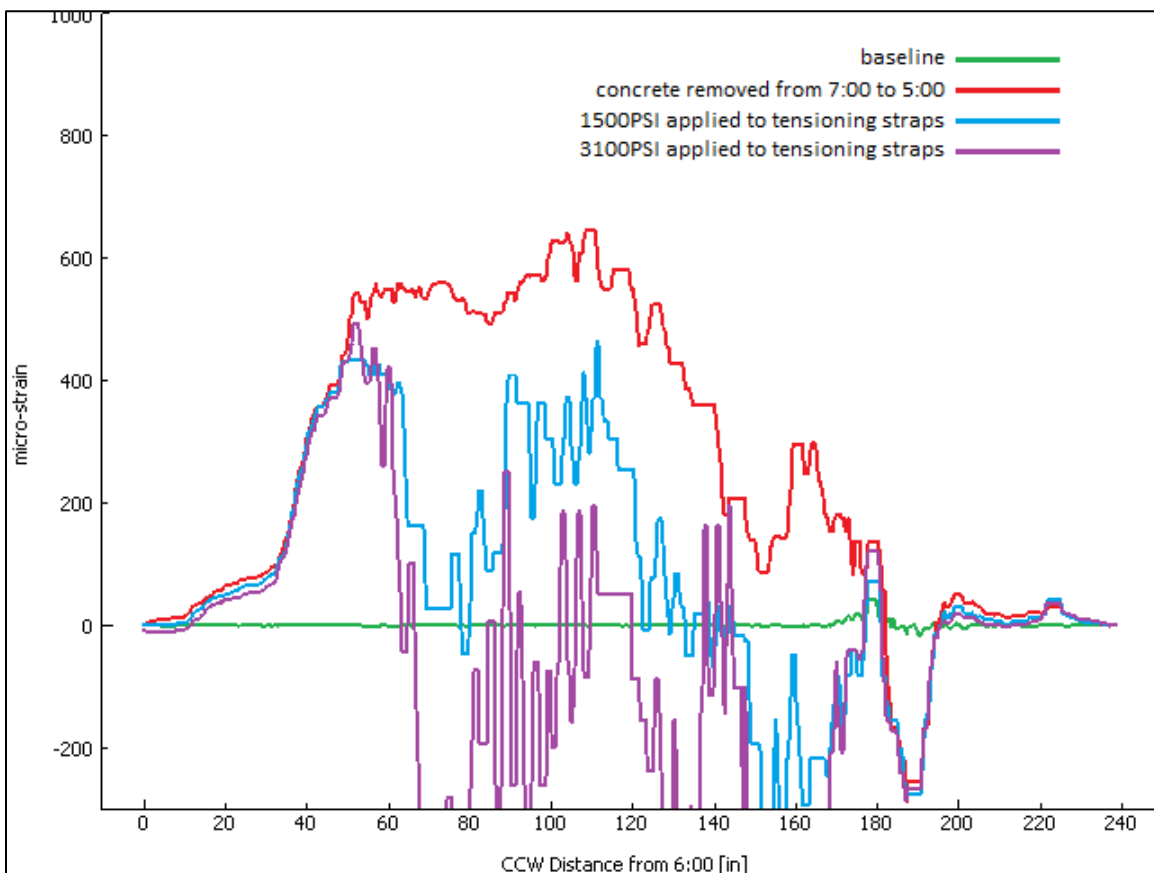
Figure 12 summarizes strain data from four different states in Segment B.

The green trace represents the baseline scan prior to any new modifications and is depicted as a flat line.

The red trace represents the strain observed after concrete and wire were removed between 7:00 to 5:00 circumferential positions. The concrete between 5:00 and 7:00 could not be removed due to difficulty of physically accessing that arclength of pipe.

The blue trace represents the application of 1,500 PSI to the three hydraulic utility cylinders. This translates to a force of 1,500 lbs along the tensioning straps.

The purple trace represents the application of 3,100 PSI to the three hydraulic utility cylinders. This translates to a force of 3,100 lbs along the tensioning straps. Although this was beyond the advertised limits of the hydraulic pump, the pressure was successfully maintained at this figure for the duration of the experiment.

The sensor data indicates that preload could be restored to near baseline conditions given sufficient tension applied to external straps. The restoration does not appear uniform around the circumference, however. This could be the result of the tensioning strap not lining up directly over the sensing fiber which is bonded on the inside of the steel cylinder – the two do not track parallel around the pipe. Additionally, preload does not appear to have restored on the side of the tensioning mechanism. This may be because the strap loses contact with the steel cylinder as it enters the tensioning device, which is resting on the remaining concrete coating. The preload force does not transfer into the cylinder because it is counteracted by the compressive force of the concrete.

Figure 12. Strain data for different stages of strain restoration on Segment B.
